# **Air Quality Assessment- TAFE Campbell Street Interim Report – John Gorrie**

## **Final Report**

**Project No: 9024**

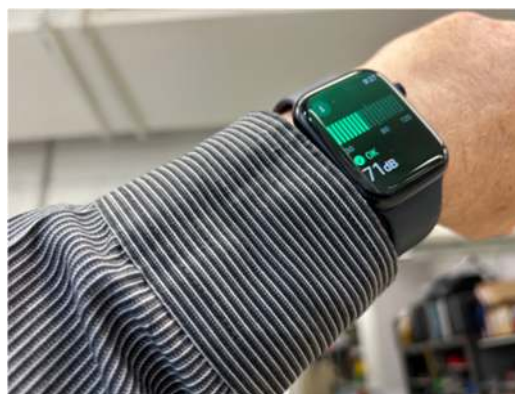
Observation in the AG-01 workshop confirmed that because training occurs inside the workshop, the General Air extraction system does not remain on, but is only run when motors are running. Also, due to the perceived noise with the general extraction fan and the motors running, the general air extraction fan is shut off if teaching is occurring in the AG-01 workshop.

**Figure 1 General Air Extraction Noise level - 71 dBA**

This action results in a contaminating event as gas would build up and move out of the workshop through AG-07 and into AG-12. The door at AG-07 must be kept closed to prevent contamination of the offices. The general air extraction system could be interlocked as it is unsafe to not have it running with engines running. If there is carbon monoxide leakage that the vehicle exhaust extraction system isn't removing e.g. from engine manifold or exhaust pipe leakage then when the general extraction system is turned off there is the potential for

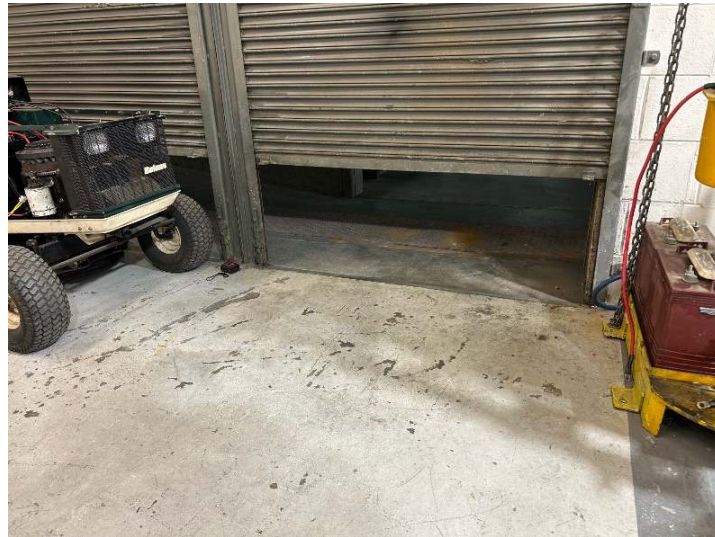
**Figure 2 Roller door north wall AG-01 workshop**

The interim assessment found that there is no dedicated / forced air flow into AG-01. The previously forced air system to the ground and basement level workshops (refer to figure 3) was investigated by TCM and found to be blanked off on the 2<sup>nd</sup> floor some years ago. The only fresh air coming into the AG-01 workshop area is via the air conditioning system located in the adjacent classroom AG-02 or through the open roller door (refer to figure 2).

Based on the low air exchange rate in AG-01, to keep the internal doors closed the workshop roller door will need to be opened (min 500 mm) to allow additional fresh air into the workshop until an alternative air inflow is in place. A Draft Standard Operating Procedure Automotive Workshops – Operations was implemented on the 1<sup>st</sup> November which addresses the operation of the general exhaust system and vehicle exhaust extraction systems. This is an interim measure which remains under review as required.

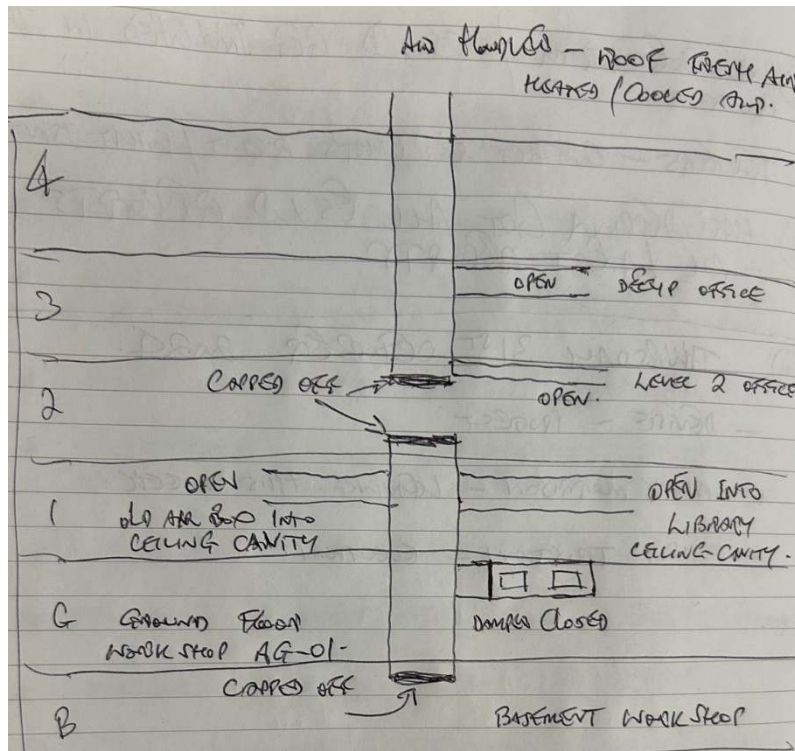
**Figure 3 diagram of previously forced air system for AG-01/Basement workshops**

The remaining ducting (refer to figure 3) can act as a conduit and gas can flow into the offices on other levels (library ceiling cavity) outside the workshop. The damper has now been closed and covers placed over the vents to isolate the ducting from other levels of the building. This system is currently being investigated by TCM to determine if it can be reinstated as a source of inflowing air into AG-01 and the basement workshop areas (along with other options to achieve the same result).

The terminated ducting (refer to figure 3) may be providing a pathway to other offices (library ceiling cavity) and floors when the extraction systems in the AG-01 workshop are not used. This ducting has now been isolated and should remain isolated until a new air inlet system is in place. We recommend that the general extraction system be on automatically and that roller doors in the short term are opened at least 500 mm (AG-01 workshop) while engines are being run. This has been covered in the safe work procedure initiated while on site.

We recommend the ducted air inlets (refer to figure 3) be investigated to determine if they can be reinstated to all of the workshops so the roller doors can be closed and doors from the offices can be kept closed (consider automatic closers on doors that must remain closed).

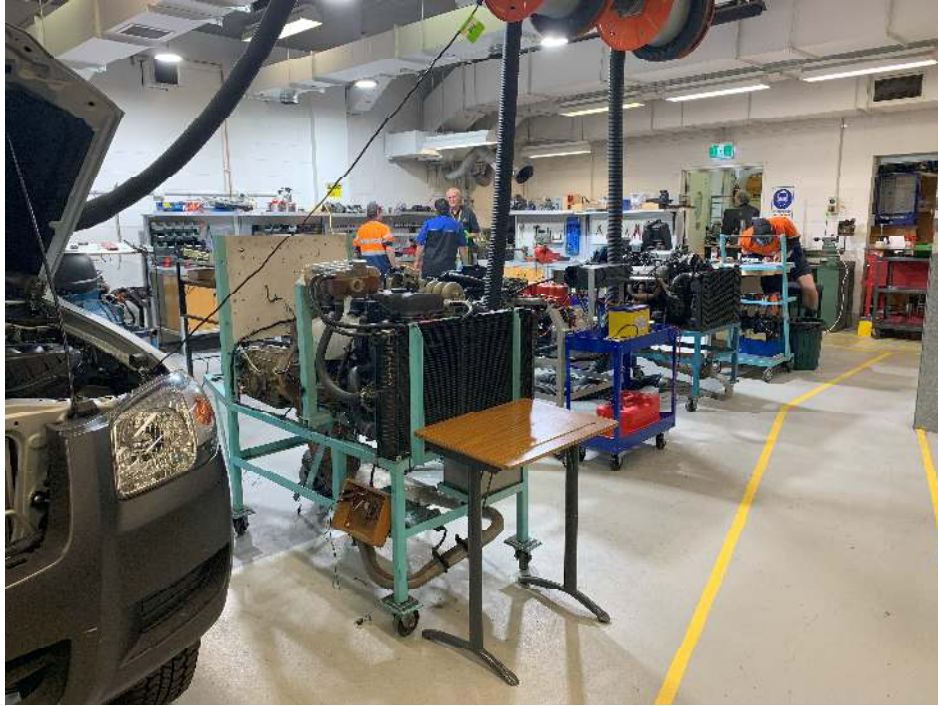
In addition, 4 out of 8 of the engines (on stands) were found to be leaking CO at, or near the exhaust manifolds. These leaks are NOT collected by the directly coupled exhaust extraction system hoses. The exhaust extraction system hoses must be connected manually to each vehicle / engine exhaust pipe. All leaks in the engines must be rectified or CO gas will leak into the workshop area if engines are left running.

**Figure 4 Entrance to AG-01 Workshop**

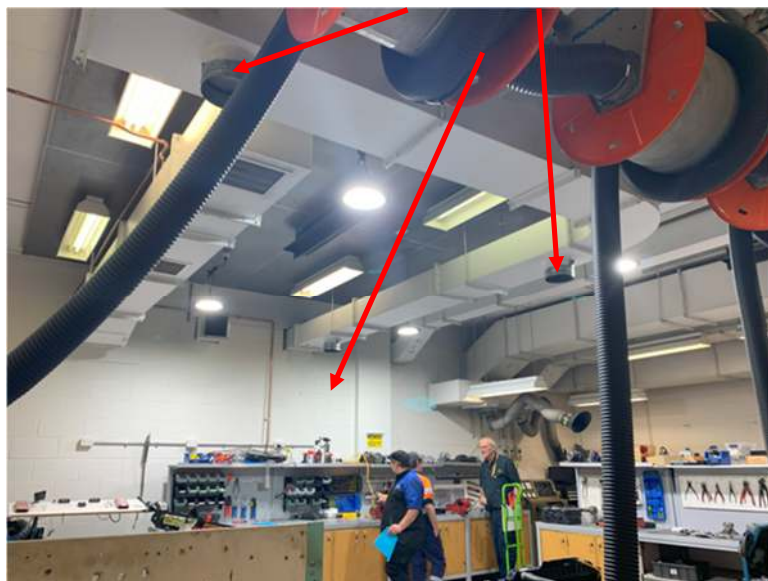
There are 3 obsolete 250 mm diameter round ducts extending from the exhaust duct system above the bank of engines. These should be sealed off to improve air flow at the exhaust system hoses where they connect to each exhaust pipe.

**Figure 5 location of unsealed ducts**The majority of stand mounted engines in the AG-01 workshop area are only operated for a short period of time.

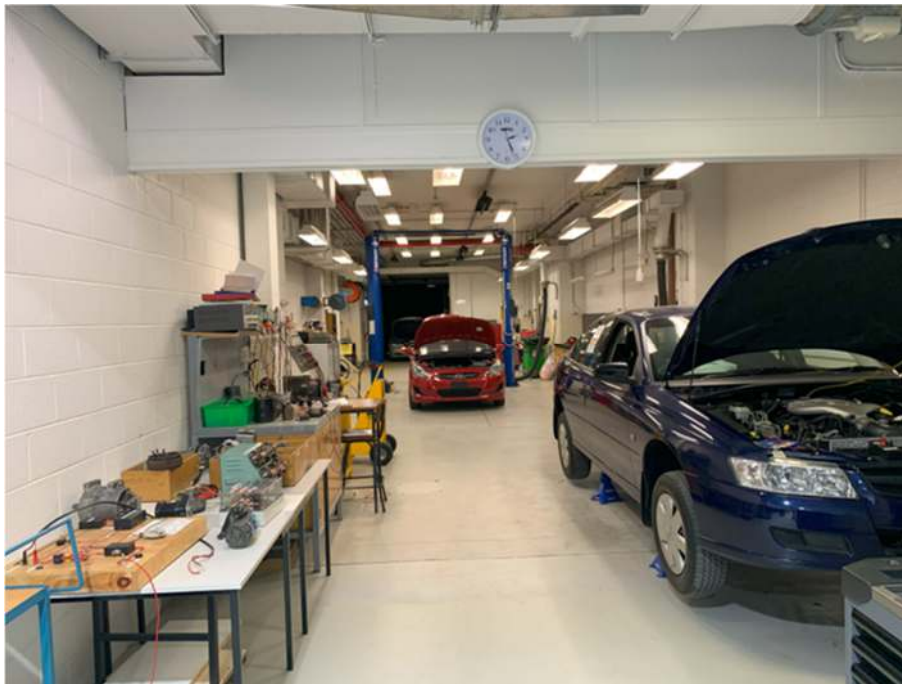
All exhaust flow rates in this area are acceptable and procedures seem to be followed. There was no discernible difference in the general exhaust system air flow with the roller door (Bathurst Street) up or down. (The Draft Standard Operating Procedure Automotive Workshops – Operations states the roller door will be open).

**Figure 6 AG-40 Electrical Workshop**

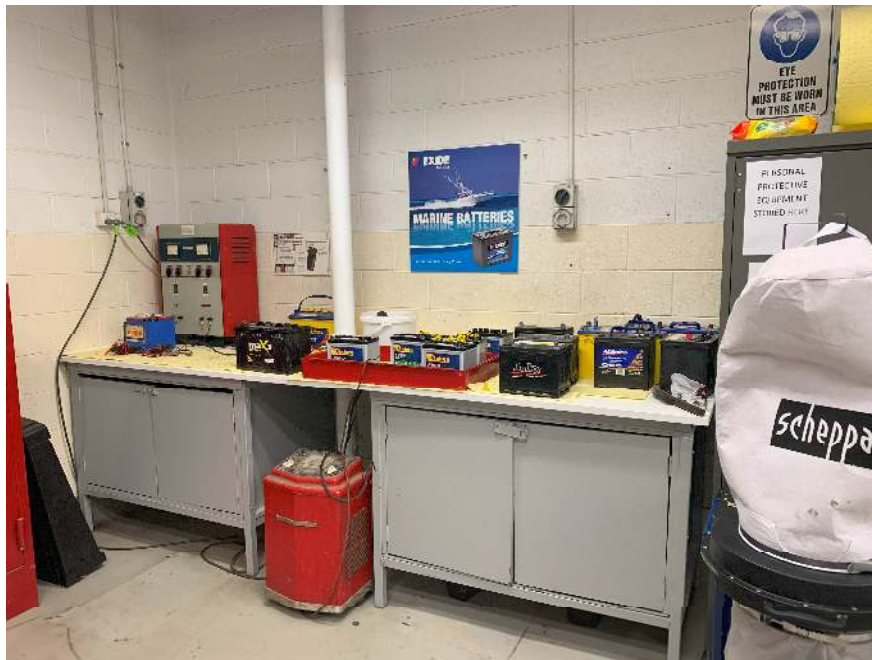
The battery storage is deemed a low risk from a vehicle gas exposure level. Usually only one battery is being charged. The battery charge area contains 17 auto batteries, with only one battery on charge at a time. This battery charging area was originally moved from the basement workshop AB-27 room which is a purpose-built battery charging room to be within the Auto Electrical Department on the ground floor level. The equipment can only charge up to 3 batteries max, (as identified by cabling). 4 batteries were open to atmosphere but not being charged at the time. There was no spillage evident. No VOC's nor O2 depletion were detected. This battery storage area could benefit from an exhaust snorkel connected to the exhaust duct directly above. Air exchange seems good. Investigation should be carried out to

**Figure 7 AG-40 Workshop Battery Area**

determine if this area can be relocated back to the purpose-built battery charging room AB-27 in the basement workshop area.

Investigate if the purpose-built battery room AB-27 can be reinstated for the charging of batteries.

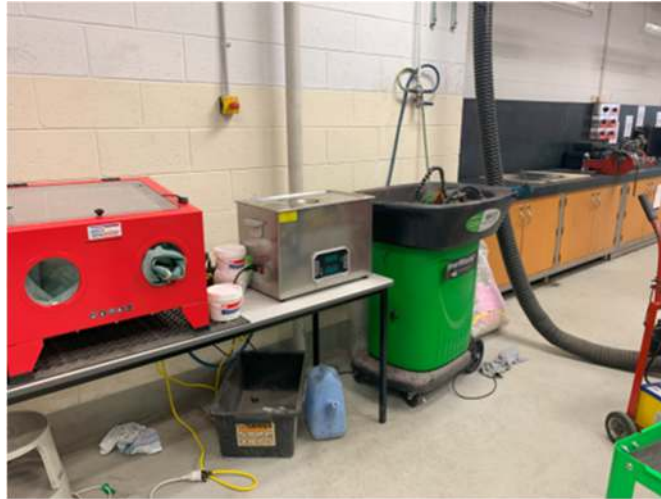
The recycling parts washer in room AG-40 is the ONLY equipment creating any VOC's in this area. This was found to be 0.7ppm near the top of unit. This unit has a re-cycle volume of nearly 40 litres and is meant to contain low volatility solvent for cleaning. Advised this unit is seldom used. 0.7 ppm VOC can have some long-term health impacts if left unchecked.

**Figure 8 AG-40 Workshop Parts Washer**

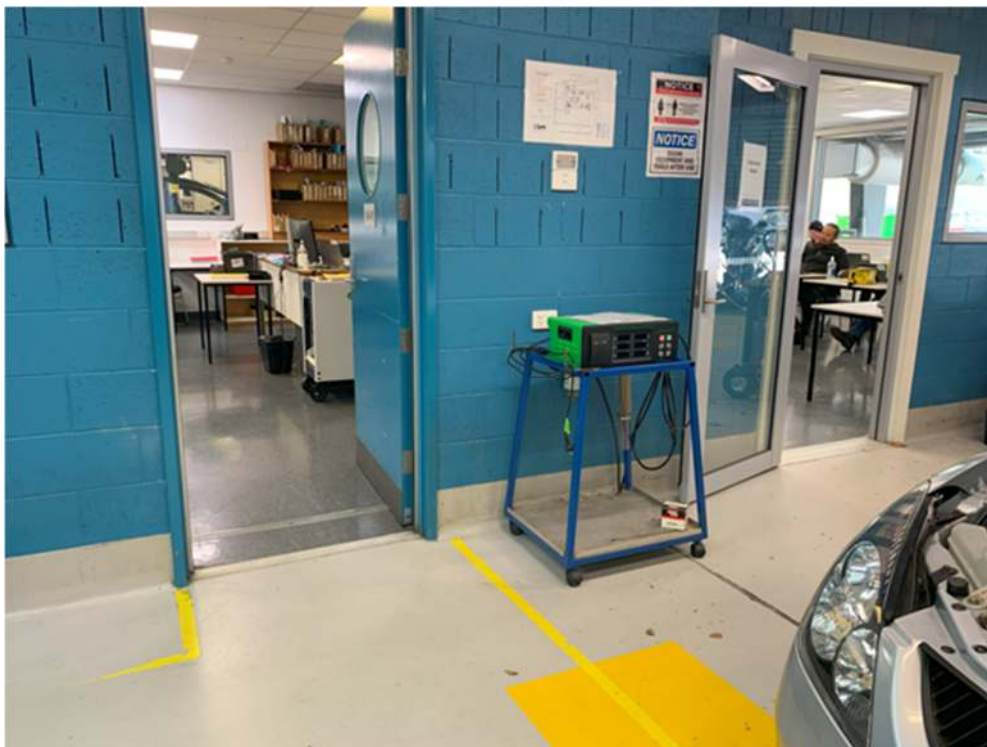
AB-03 Classroom was checked for CO while a car idled close by (outside the entry door to the classroom). No CO was detected in the workshop, or in the classroom. It was disclosed by staff that a significant exhaust leak was detected and repaired the previous week on the vehicle that is located immediately outside the door to the AB-03 classroom.

**Figure 9 - Entrance to classrooms off AB-02 Workshop**

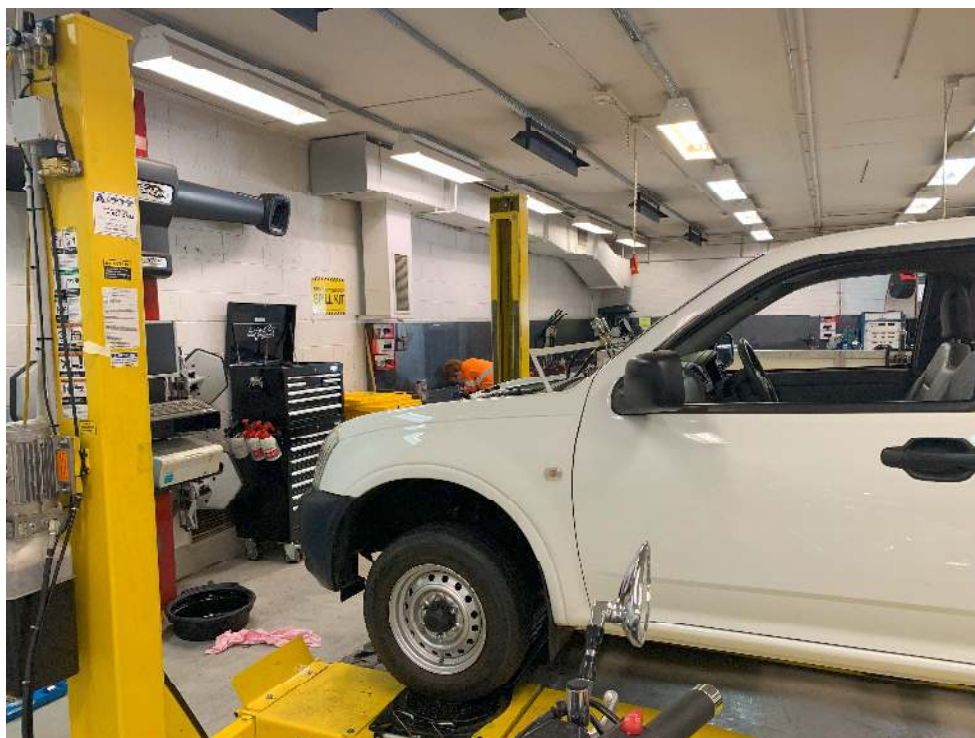
One asset [Rodeo Ute] was found to have a CO leak at the engine manifold. A teacher advised that this is a staged / deliberate CO leak in the engine manifold / exhaust system so the students can diagnose the fault as part of an assessment. This vehicle should have an extraction snorkel mounted above the engine to safeguard human health by removing any CO from the breathing zone of apprentices / teachers when carrying out these assessments. Advice received was that the vehicle engine is only run for a short period of time for this assessment process e.g. less than 5 minutes.

**Figure 10 Rodeo in AB-01 Workshop**

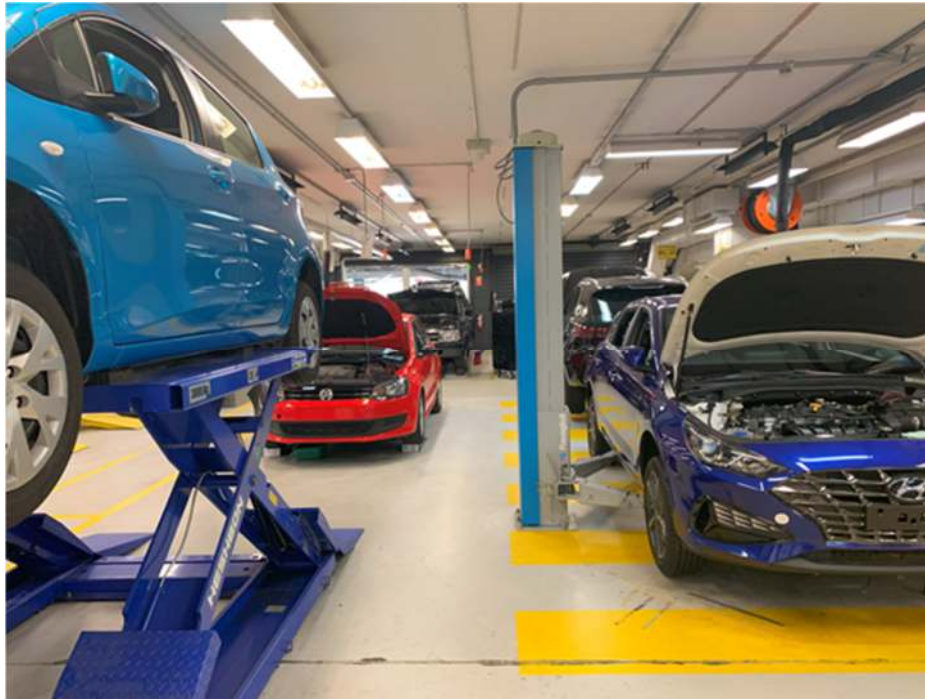
All other (6) vehicles in this area were found with no adverse emissions on this date.

**Figure 11 Other vehicles in AB-01 Workshop**

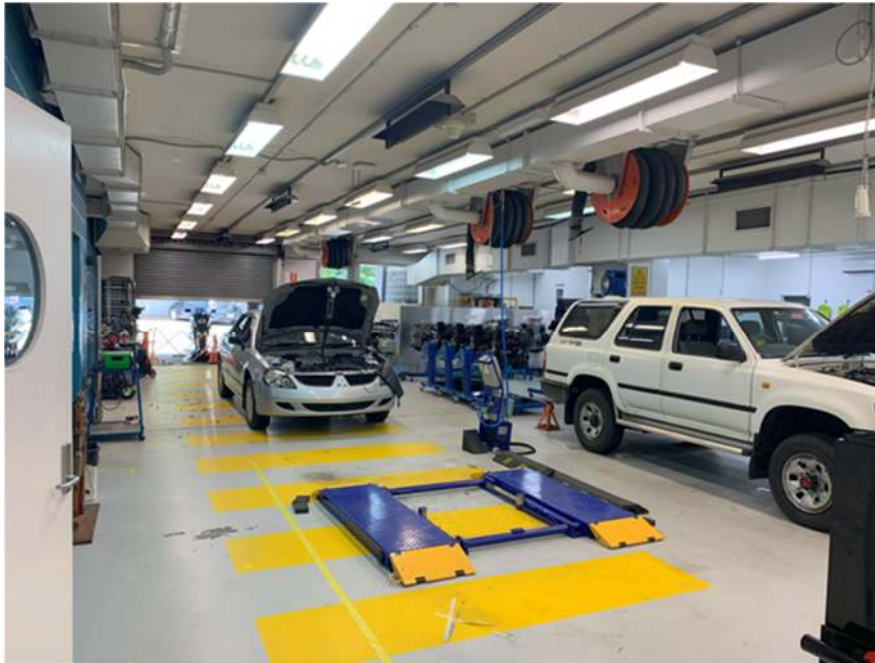
All air flow rates in the basement workshop area are acceptable. There was no discernible difference in the general exhaust system air flow with the roller door up or down on the date of testing. **Note:** Further engineering assessments will determine correct air flows.

**Figure 12 AB-02 & AB-18 Workshop Areas**

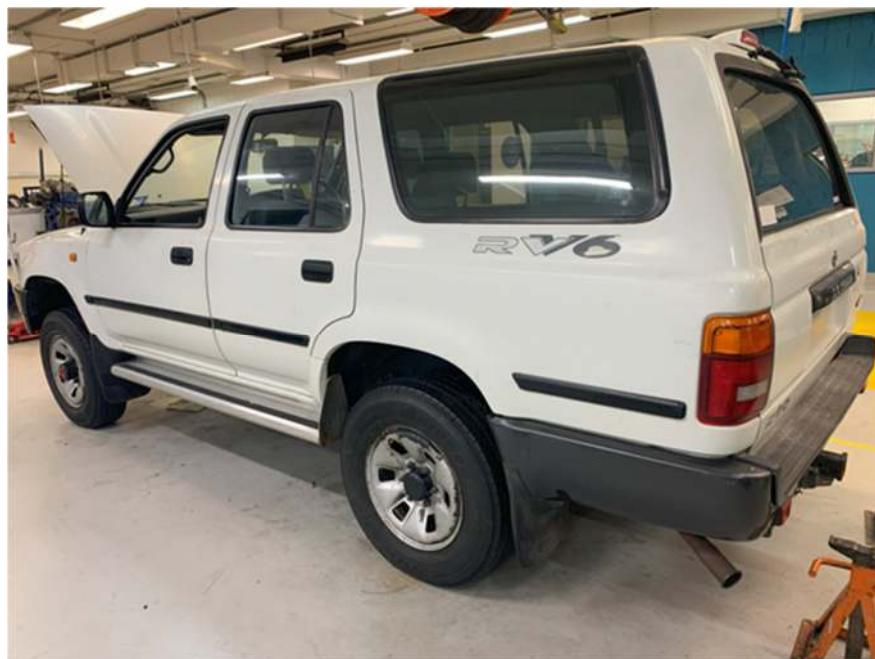
Two assets (1 vehicle Toyota forerunner (see photo below) and 1 freestanding engine) were found to be leaking CO, at either the exhaust manifold or the exhaust pipework flange gasket. Both were locked out and isolated by teaching staff. One has been repaired and cleared, using the TAFE owned RIKEN KEIKI air quality meter.

**Figure 13 Leaking exhaust system - Toyota Forerunner**

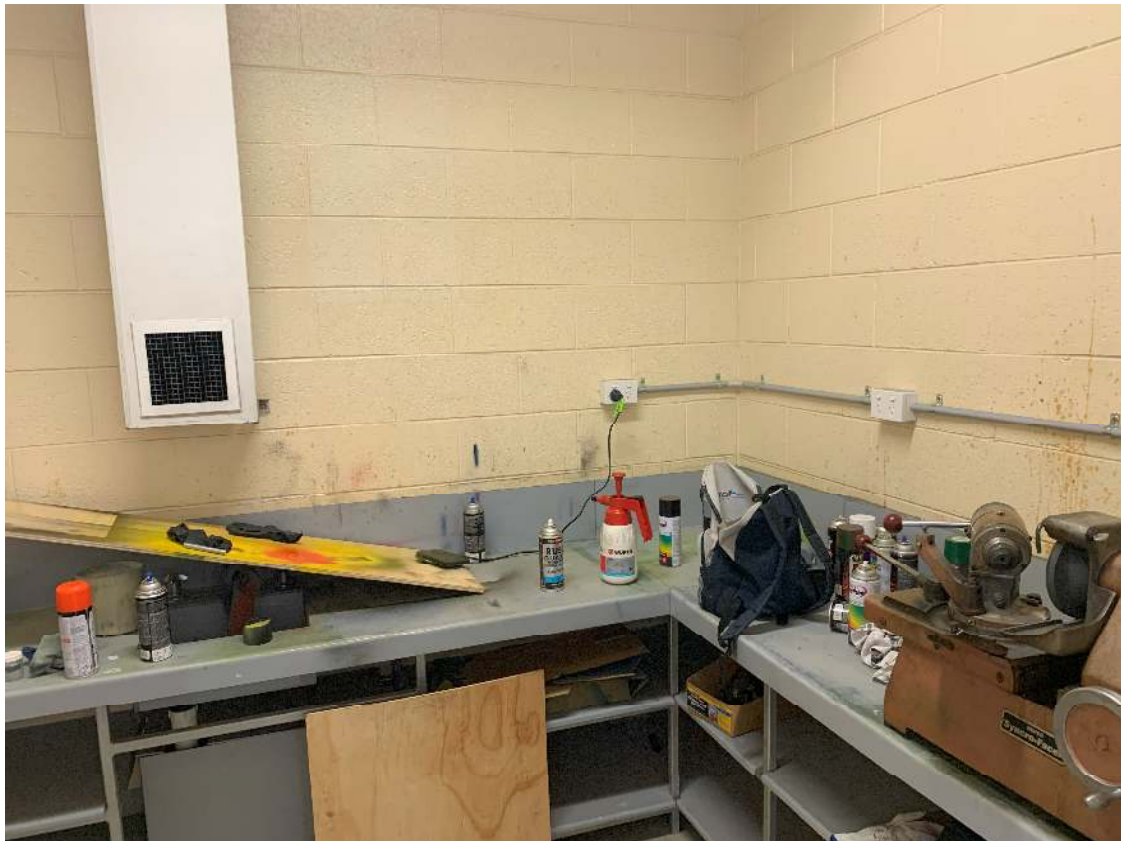
This room has dedicated extraction exhaust flow of 8000 to 10000 CMM. This room is now used as a general storage room by the Auto Mechanical Dept. (Refer to Recommendations at the end of this document).

**Figure 14 AB-27 Room - Former Battery Storage Area**

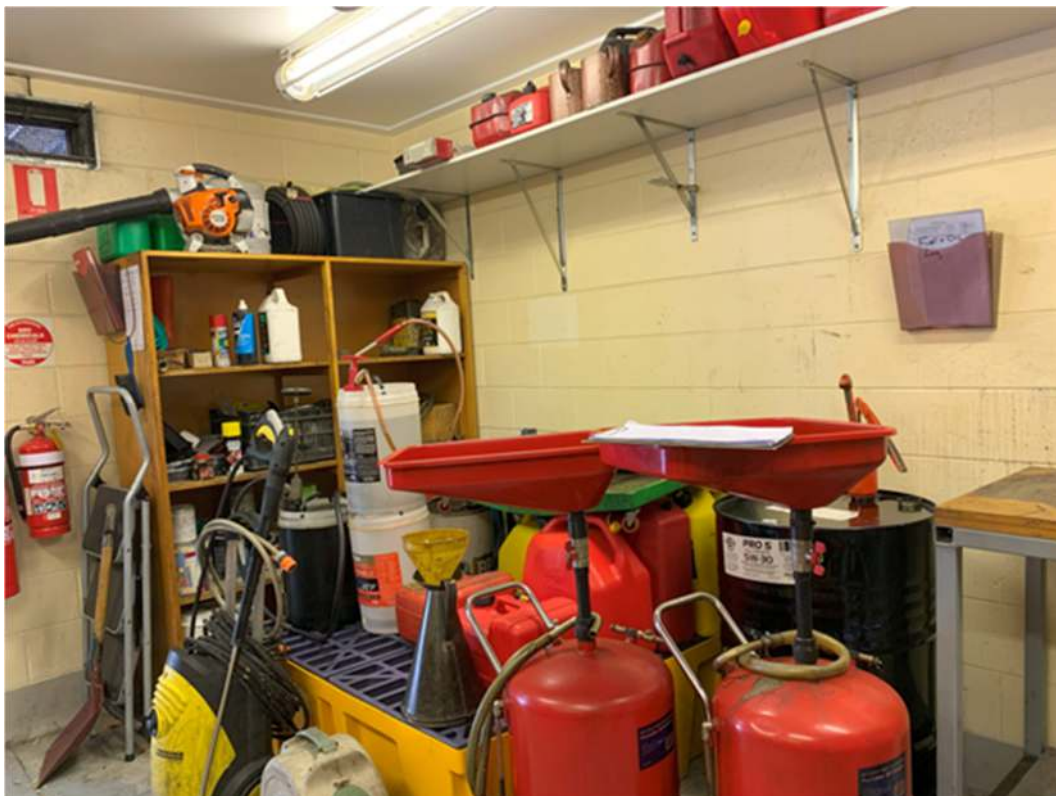
The VOC in this room was 0.4ppm, with a background level nearby of 0.1 ppm, which could have long term impacts if left unchecked.

The room contains 2 x 200Lt drums of Petrol, General Purpose Oil, one waste Oil container.

Storage could be better organised. Wooden shelving is inappropriate for the area. The outside door to this should be kept locked at all times, especially as it is easily accessible by anybody outside in the carpark area.

**Figure 15 AB-15 Room - Solvent / Flammable Liquid Storage**
